# 1 Example St, Brisbane QLD 4000, Australia

Inspection Date: 6 May 2026

## Executive Summary

Roof Information - Default - Main Roof

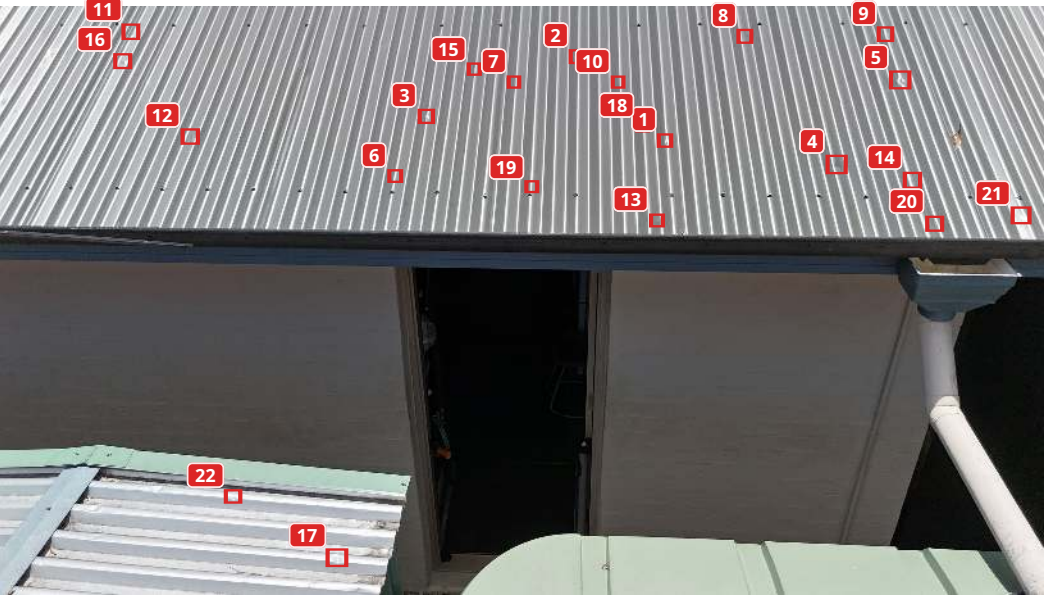
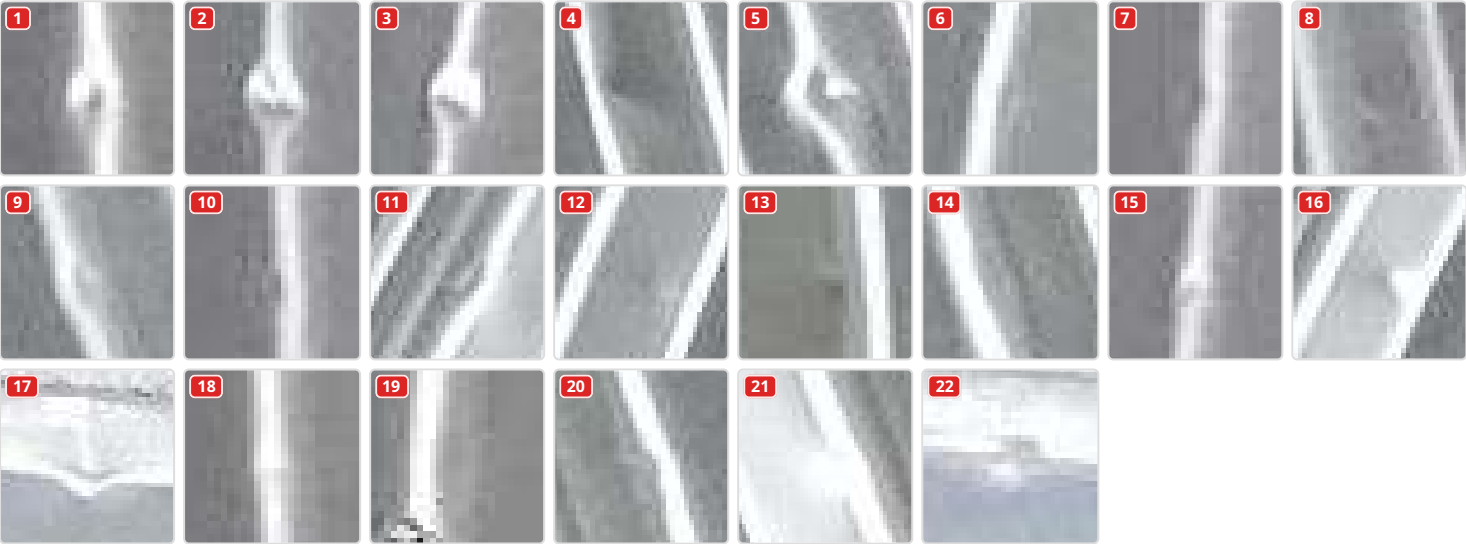
Lat: -27.5605734  
Lon: 152.90124

● Hail Hit 22

● Hail Hit

insurable

**Description:** Hails Hits have caused dents in roof & or sheet metal sheeting that can affect the structural integrity of the material depending on the size, location, and severity of the dent.

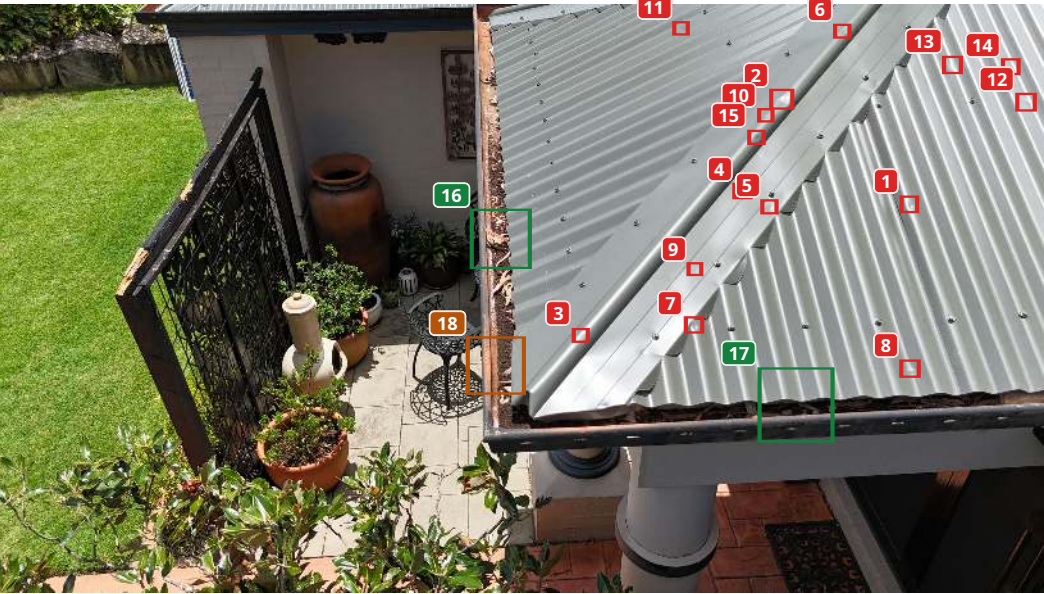
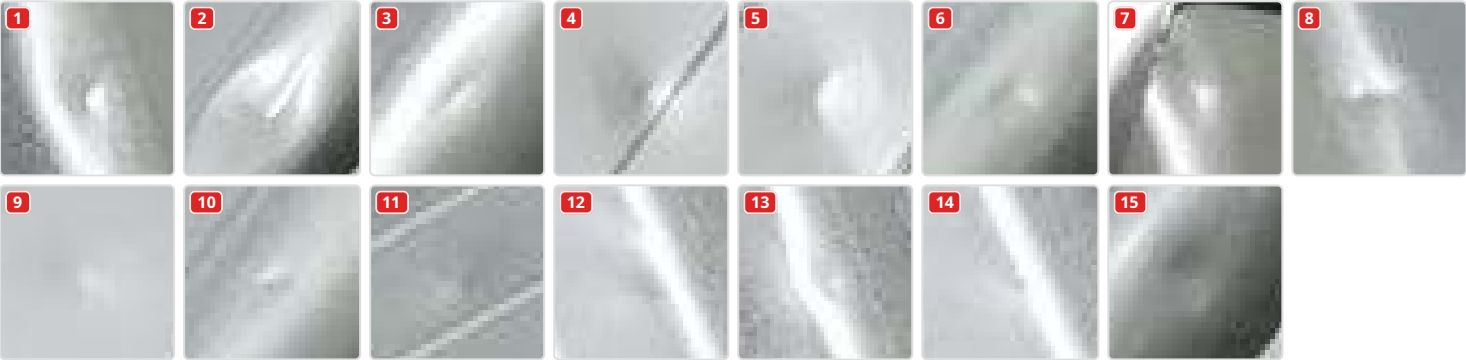
Lat: -27.5605089  
Lon: 152.9012031

- Hail Hit 15
- Organic Debris 2
- Rust 1

Hail Hit

insurable

**Description:** Hails Hits have caused dents in roof & or sheet metal sheeting that can affect the structural integrity of the material depending on the size, location, and severity of the dent.

Organic Debris

maintenance

**Description:** The accumulation of organic matter can block roof sheet pans, gutters, and down pipes, reducing the efficacy of the drainage system. Organic matter holds moisture, creating a corrosive environment, which accelerates the degradation of the roof, and drainage system.

Rust

**Description:** Rust on sheet metal roofs occurs due to metal oxidation from moisture and oxygen exposure. Due to prior scratched or damaged material. It weakens the material, causing potential structural issues and leaks.

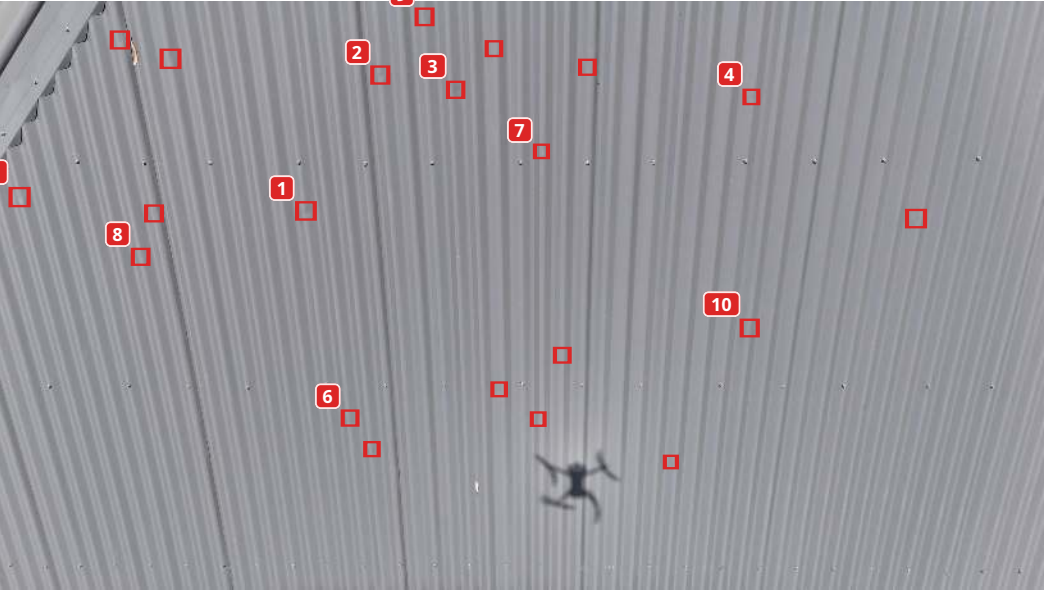
Lat: -27.5605431  
Lon: 152.9011947

Hail Hit

21

insurable

**Description:** Hails Hits have caused dents in roof & or sheet metal sheeting that can affect the structural integrity of the material depending on the size, location, and severity of the dent.

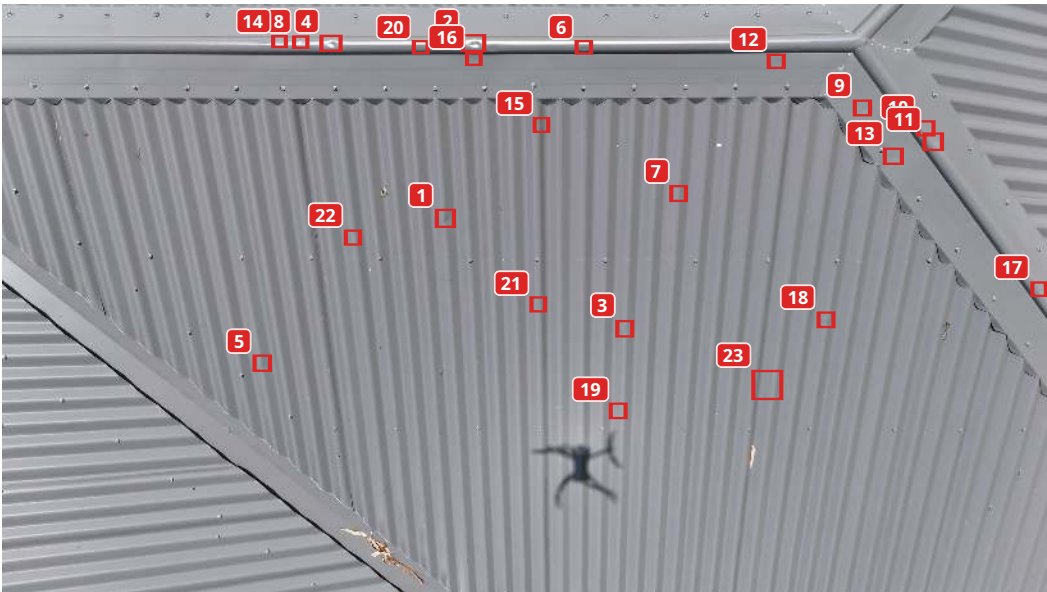
Lat: -27.5604836  
Lon: 152.9013476

Hail Hit

23

insurable

**Description:** Hails Hits have caused dents in roof & or sheet metal sheeting that can affect the structural integrity of the material depending on the size, location, and severity of the dent.

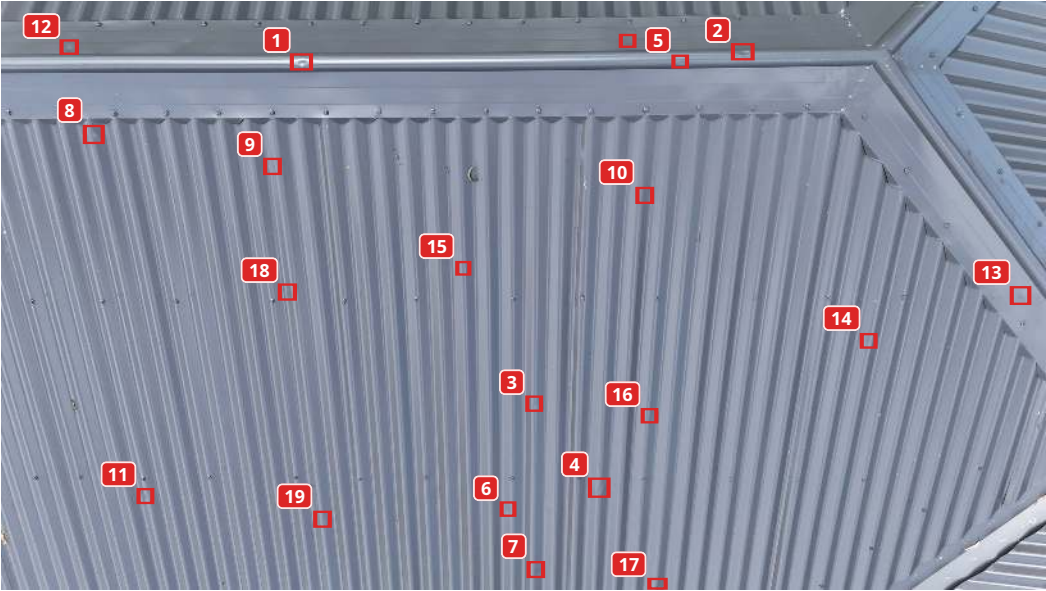
Lat: -27.560508  
Lon: 152.9012648

● Hail Hit

20

insurable

**Description:** Hails Hits have caused dents in roof & or sheet metal sheeting that can affect the structural integrity of the material depending on the size, location, and severity of the dent.

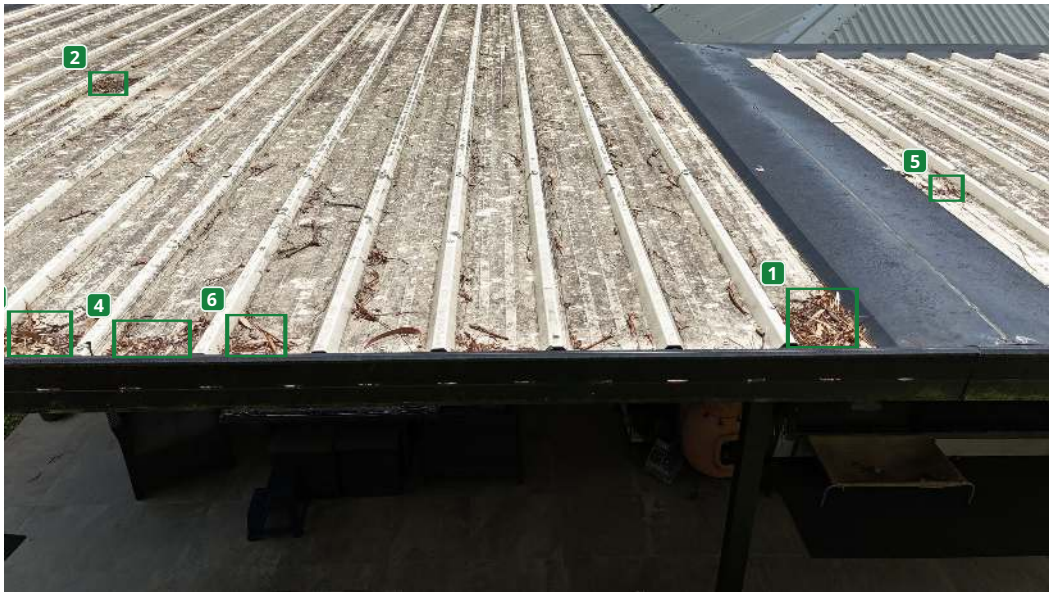
Lat: -27.5605113  
Lon: 152.9014371

● Organic Debris 6

● Organic Debris

[maintenance](#)

**Description:** The accumulation of organic matter can block roof sheet pans, gutters, and down pipes, reducing the efficacy of the drainage system. Organic matter holds moisture, creating a corrosive environment, which accelerates the degradation of the roof, and drainage system.

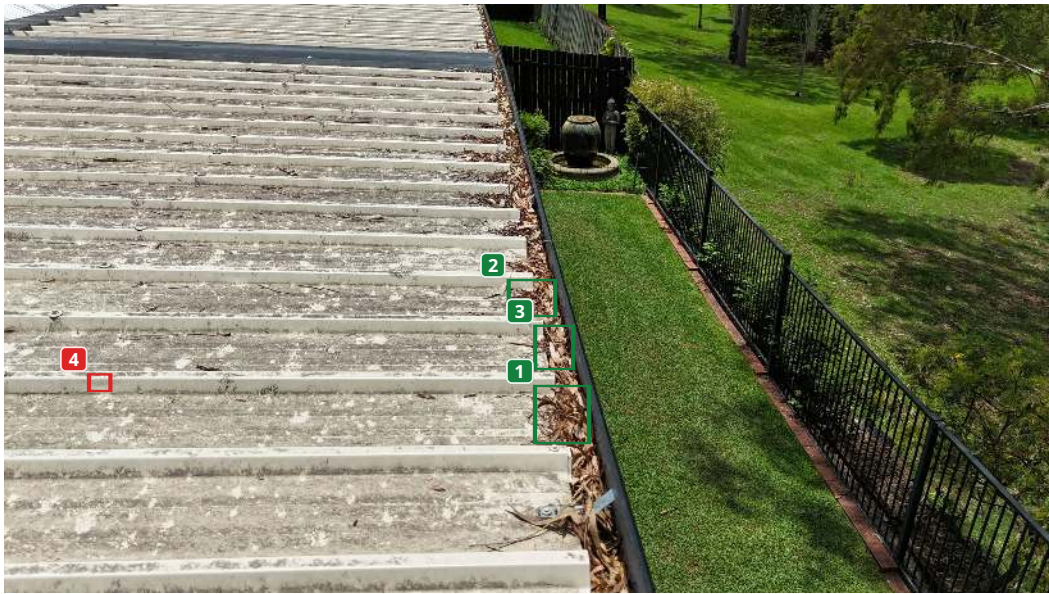
Lat: -27.5605621  
Lon: 152.9013899

- Organic Debris 3
- Hail Hit 1

### ● Organic Debris

maintenance

**Description:** The accumulation of organic matter can block roof sheet pans, gutters, and down pipes, reducing the efficacy of the drainage system. Organic matter holds moisture, creating a corrosive environment, which accelerates the degradation of the roof, and drainage system.

### ● Hail Hit

insurable

**Description:** Hails Hits have caused dents in roof & or sheet metal sheeting that can affect the structural integrity of the material depending on the size, location, and severity of the dent.
