# 1 Example St, Brisbane QLD 4000, Australia

Inspection Date: 6 May 2026

## Executive Summary

Roof Information - Default - Main Roof

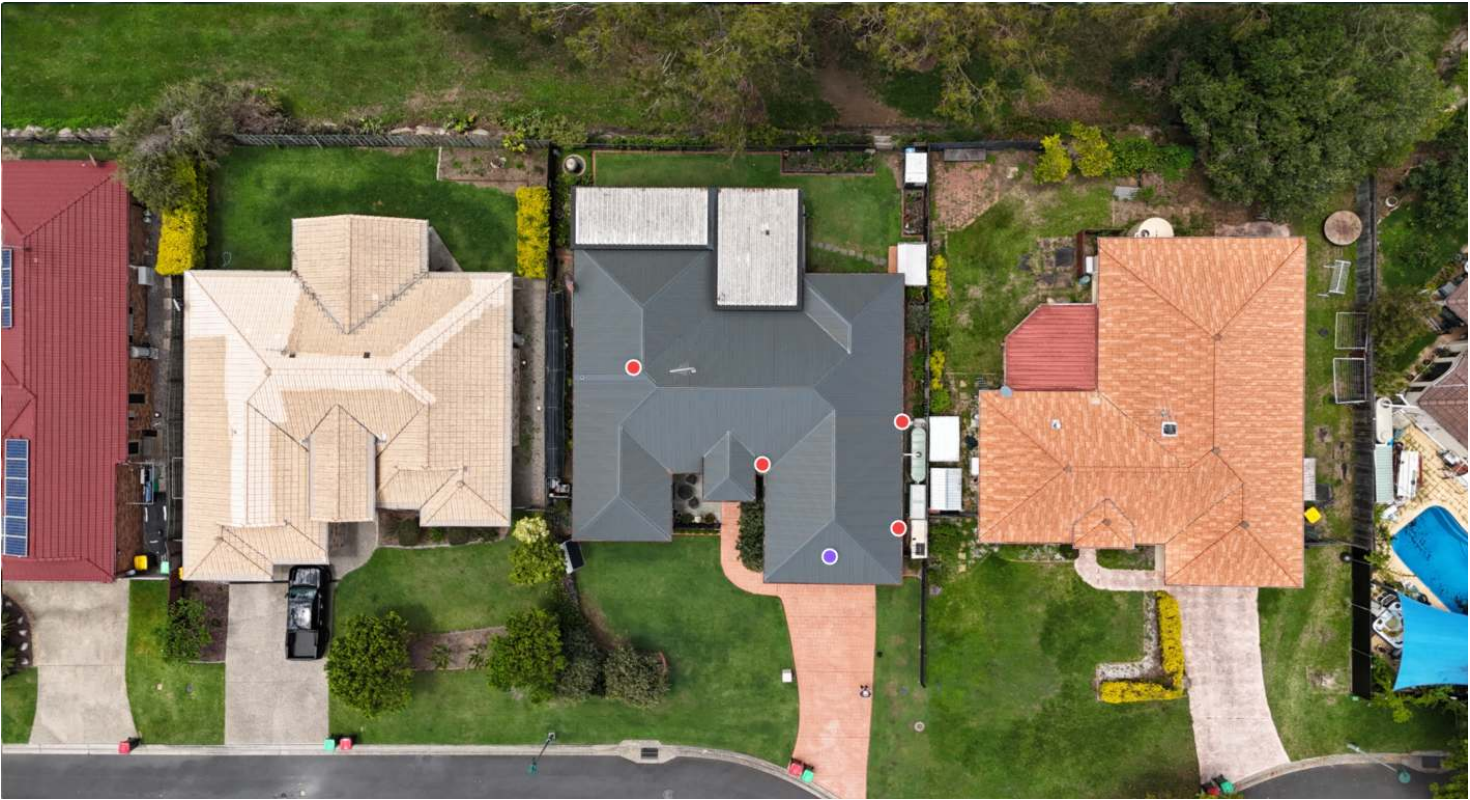
Main Roof

● Insurable (4)   ● Multiple (1)

**Description:** Hails Hits have caused dents in roof & or sheet metal sheeting that can affect the structural integrity of the material depending on the size, location, and severity of the dent.

Replace all roof sheeting and associated flashings
